**CUSTOMER SERVICE AND DISTRIBUTION**

Distribution Asset Maintenance Department

**Distribution Asset Condition**

DATE PREPARED: 2012 08 14

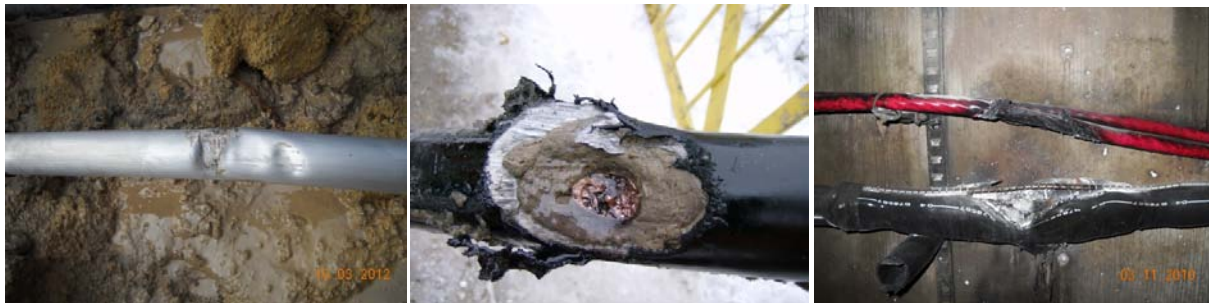
Mechanical damage to underground cables is primarily caused from external factors. Examples include excavation or construction equipment contacting energized underground cables or vehicular accidents striking a cable lateral pole. Either incident could result in breaching of the cable insulation, resulting in a cable fault or damage to the cable material. The resultant damage, even if it does not manifest as an immediate fault, could result in a future cable failure due to increased cable electrical stress or moisture ingress into the cable insulation. Photos of cable damage are provided in Figure 7.

Denting of 66 kV Cable Sheath from Construction Equipment

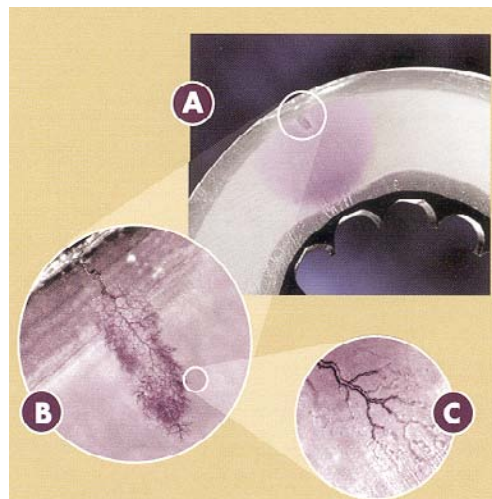
**Figure 8** Electrical Tree Formation on XLPE Cable

The main cause of degradation of XLPE cables is the formation of water trees. These defects are caused by the presence of microscopic voids in the insulation, that under electric field stress attract water. As water diffuses into the material over time it forms a “water tree”. The cable’s electric field causes the water to oxidize in the polyethylene, creating more electrical stress that causes more water to be attracted to the area. This process continues until localized arcing occurs in the cable insulation and an electrical tree is formed, leading to cable failure. A photo of a water tree which has developed into an electrical tree is provided in Figure 8.

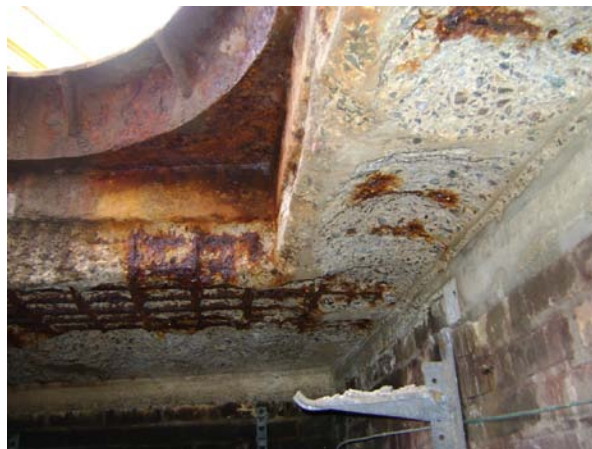
**Figure 14** Compromised Manhole Roof

Initial degradation of a manhole typically involves corrosion of any reinforcing steel and weakening of the underlying concrete or brick structural foundation. A photo of a manhole with a compromised roof is provided in Figure 14.

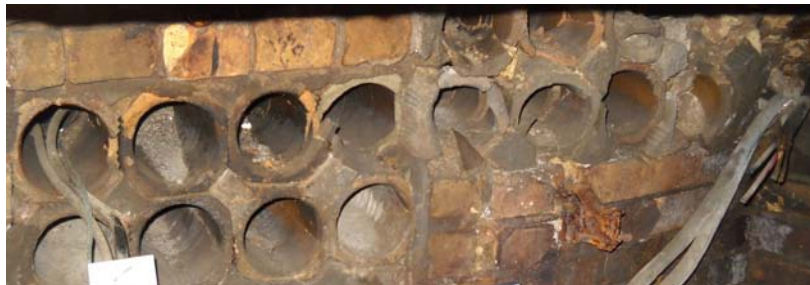
**Figure 20** Crumbling Clay Tile Duct Line

Mechanical failure of a duct line is typically associated with shifting of the duct section and pinching existing cables. In addition, failure of individual duct sections between manholes is also possible, but not always detectable until a new cable installation is required. Clay tile duct lines are considered the most likely to fail on Manitoba Hydro's system due to their age (1920's installation dates) and are not recommended to be used for new cable installations. A photo of a crumbling clay tile duct line is provided in Figure 20.

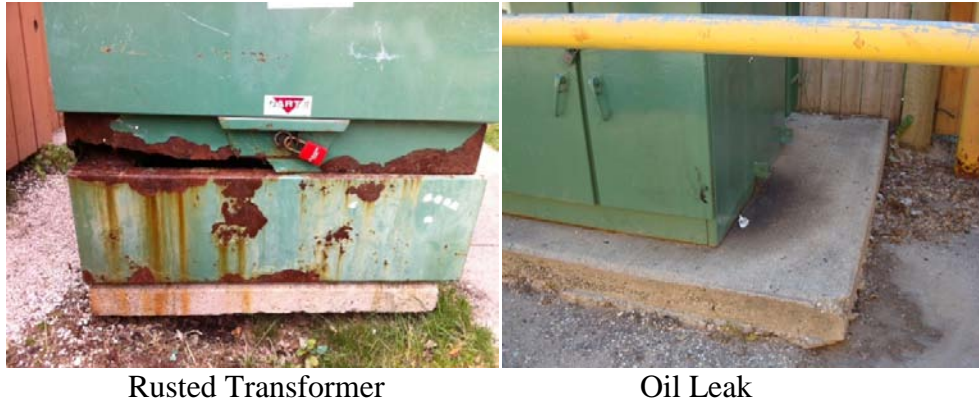
**Figure 26** Padmount Transformer Degradation

In addition, padmount transformers are more susceptible to corrosion due to their close contact with moist soil conditions, limited air flow around the tank, and increased exposure to road salt when installed close to roadways. Underground transformers often fail due to oil leakage from the bushings, welded seams, or areas that have rusted through. Padmount transformers can be expected to last 35 years or more in the field. Typical causes of failures are provided in Figure 26.

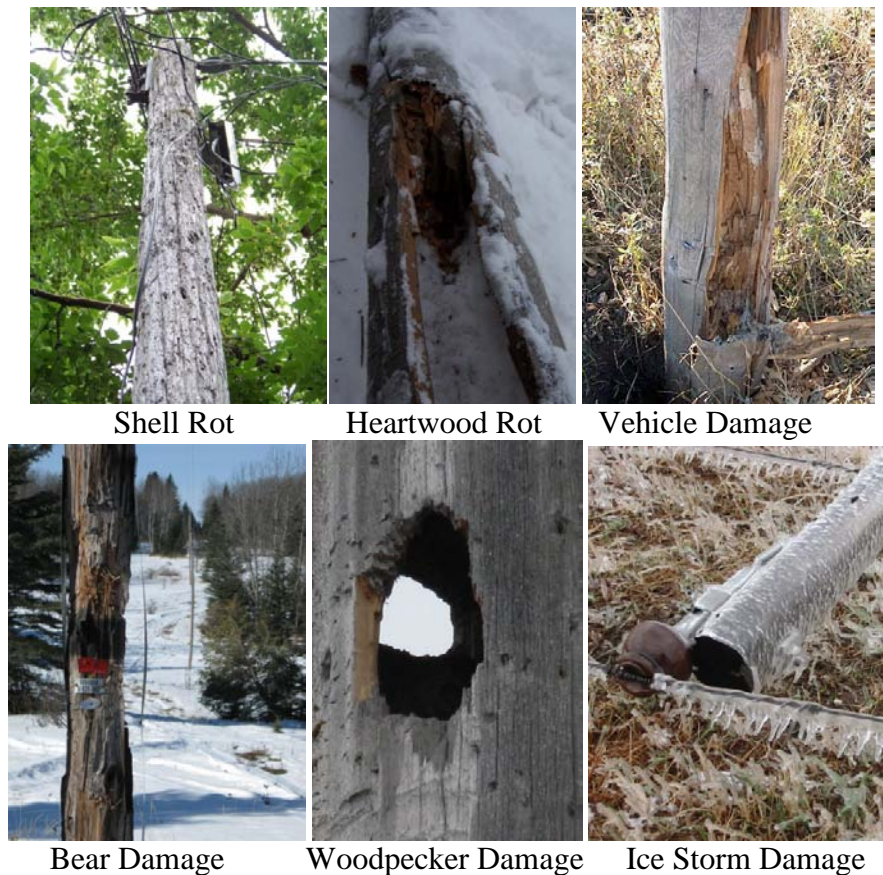
**Figure 34** Typical Causes of Wood Pole Degradation

Other factors impacting pole strength include wildlife or vehicle damage. Poles are a structural component of the distribution system and the major concern when assessing their condition is the reduction in mechanical strength that is usually caused from decay or by physical damage from equipment or fire. Typical causes of wood pole degradation are provided in Figure 34.

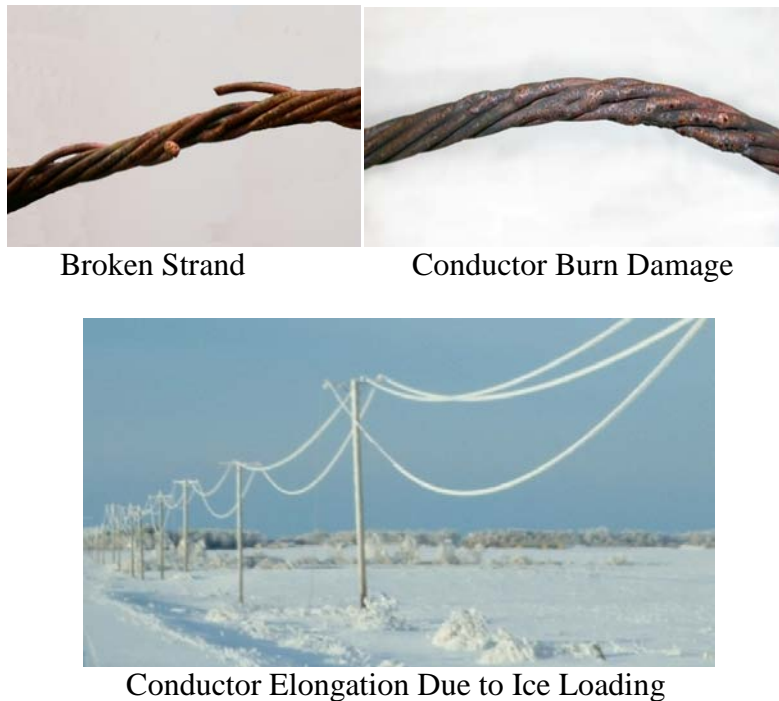
**Figure 41** Typical Causes of Overhead Conductor Damage

Typical causes of conductor failure are provided in Figure 41. The causes (left to right) (top row) are: broken strands and burn damage; (bottom row) and conductor elongation due to ice loading.

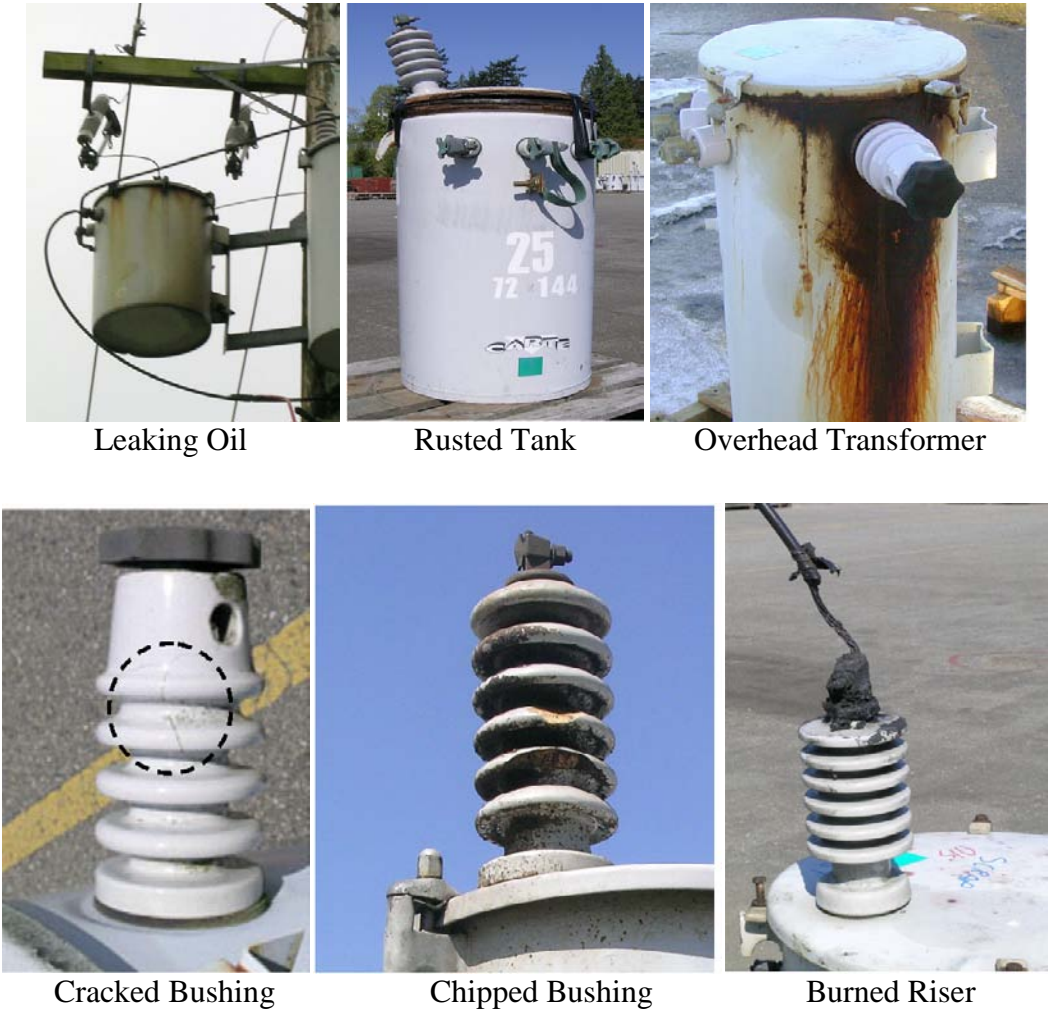
**Figure 47** Typical Causes of Overhead Transformer Degradation

Typical causes of transformer failures are provided in Figure 47.

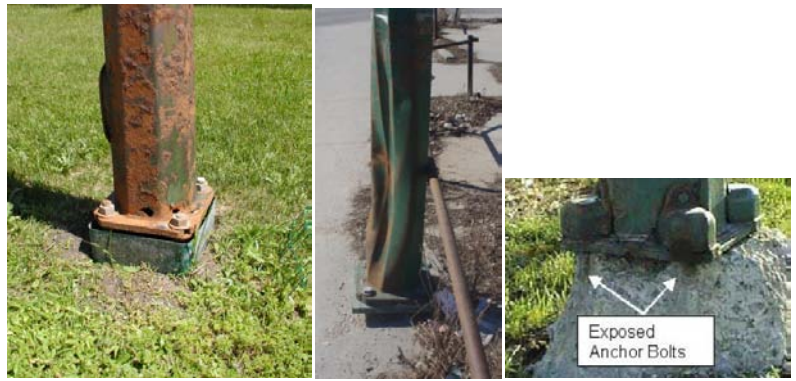
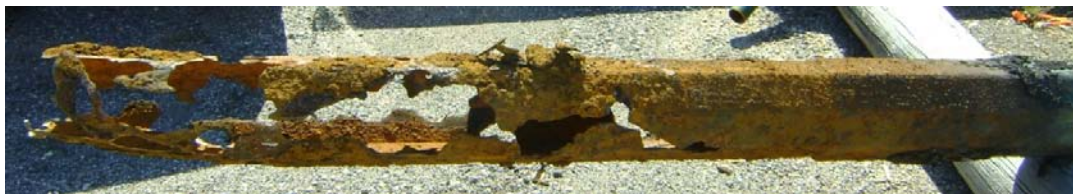
Another factor impacting streetlight strength is damage caused by contact from snow clearing or construction equipment and vehicular accidents. Dents, cuts, or severe damage from this type of contact can also result in the failure of a standard. Typical causes of streetlight degradation are provided in Figure 53. The causes (left to right) are (top row): above grade corrosion and damage from vehicular or construction equipment contact; (bottom row) below grade corrosion and concrete pile degradation.

Above Ground  
Corrosion

Concrete Degradation

Below Ground Corrosion
