MANITOBA HYDRO

2012/13 & 2013/14 ELECTRIC GENERAL RATE APPLICATION

PUBLIC UTILITIES BOARD (“PUB”) PRE-ASK QUESTIONS OF MANITOBA HYDRO

**Pointe du Bois Spillway Replacement
Incremental Consequence Classification and
Selection of Inflow Design Flood
Deliverable No: P-1.3.2.2.0440.1 Rev 0
Manitoba Hydro File 00102-11340-0011_02**

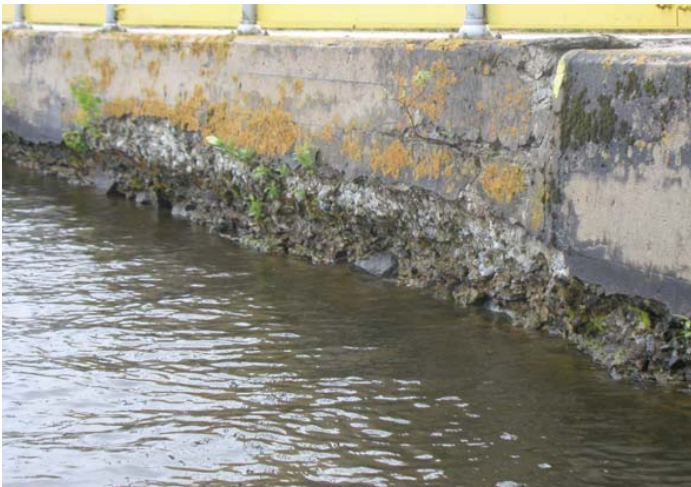
Photo 1: Extensive concrete freeze-thaw deterioration at water level on west gravity dam.

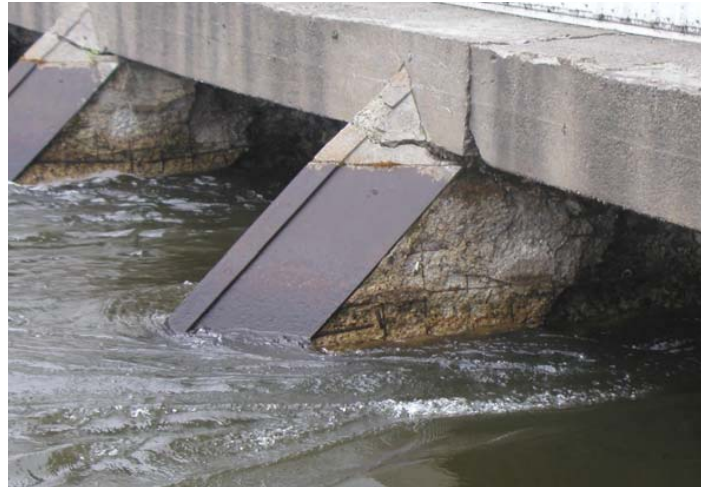
Photo 2: Freeze-thaw deterioration at water level on the intake piers

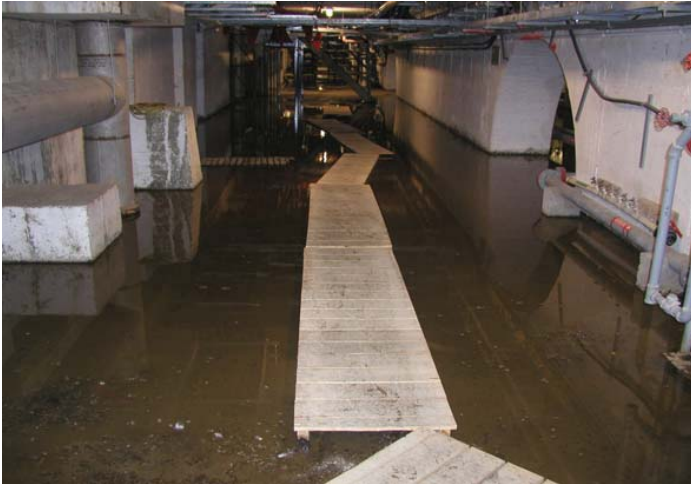
Photo 3: Approximately 40 mm of water on the basement floor due to high tail water.

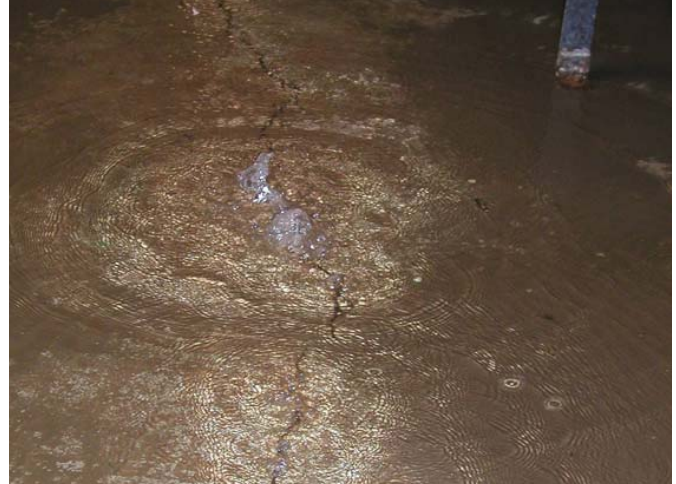
Photo 4: Water coming up through cracks in basement floor; typical.

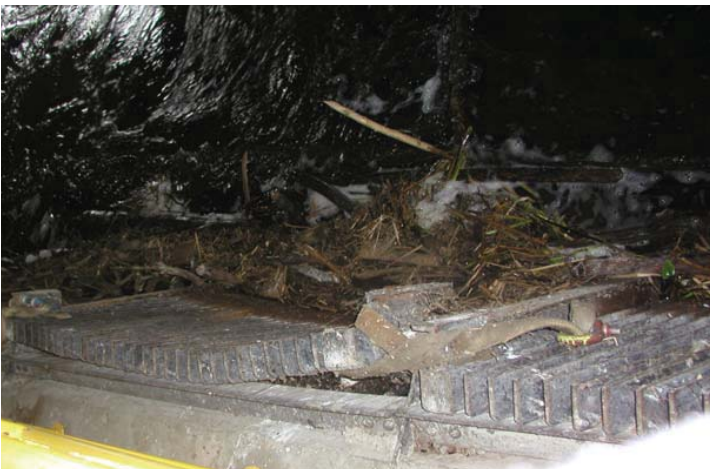
Photo 5: Damaged trash racks and slight debris upstream of unit 6 and 9 .

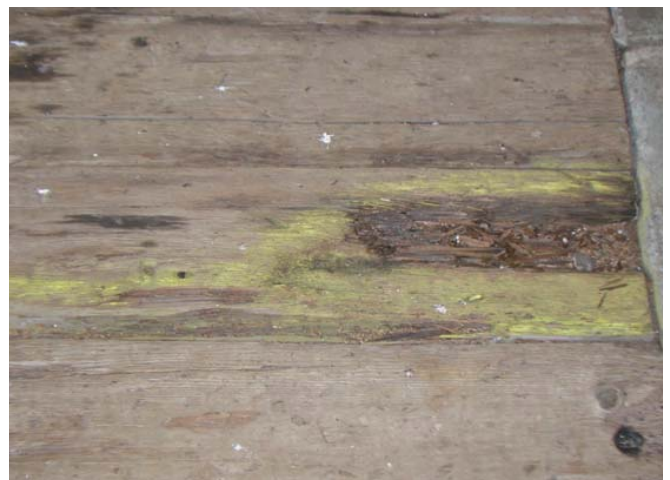
Photo 6: Damaged wood cover in the intake gate room, upstream of unit 12.

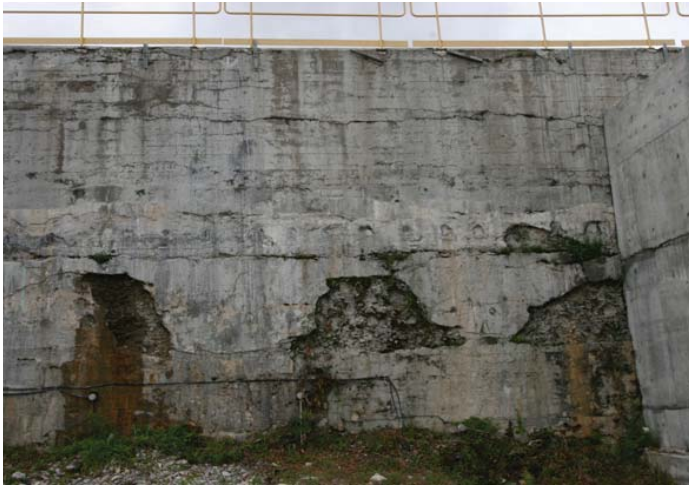
Photo 7: Concrete spalls along downstream north end of east gravity dam; leakage is evident through cracks (typical).

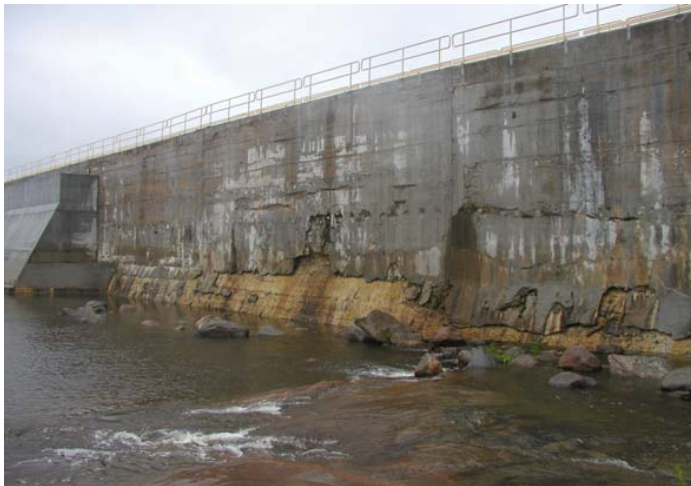
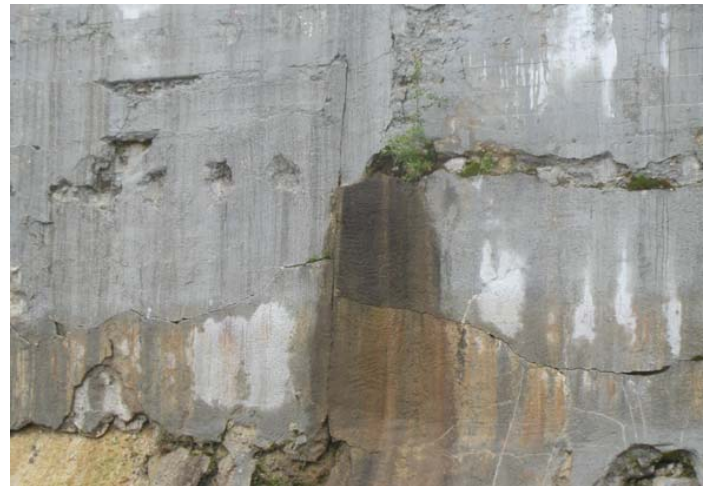
Photos 9 & 10: Concrete spill and leakage at block 19; concrete is offset to 75 mm.

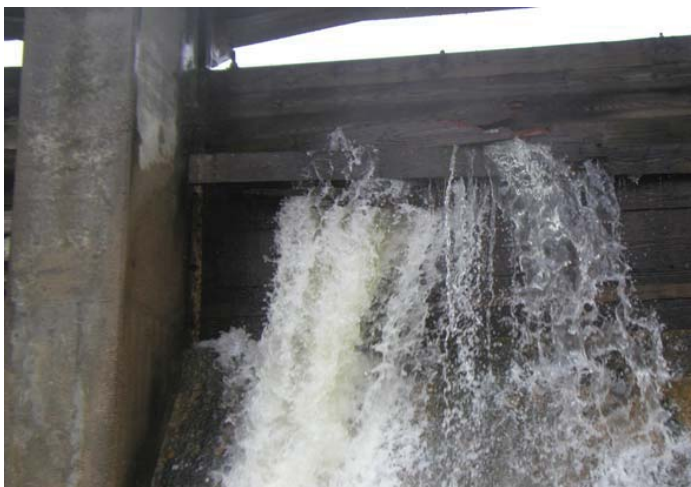
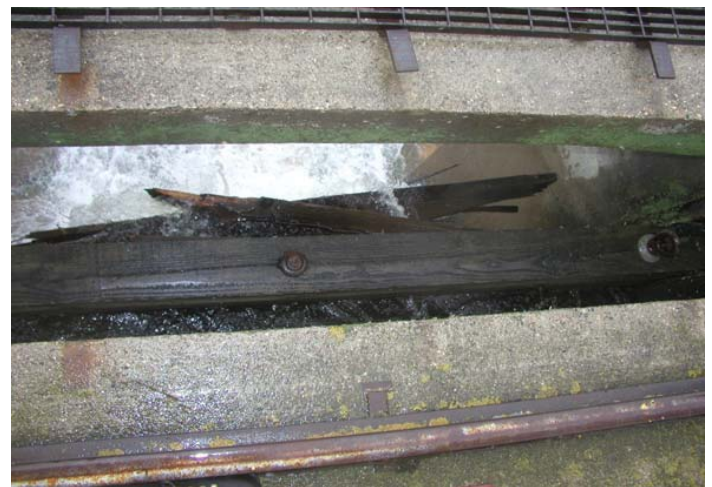
Photos 11 & 12: Stoplogs are damaged in the curved spillway bay 112, due to high ice flow in spring, as noted during the spring inspection. Damage and leakage appears to have increased.
