**CUSTOMER SERVICE AND DISTRIBUTION**

Distribution Asset Maintenance Department

**Distribution Asset Condition**

DATE PREPARED: 2012 08 14

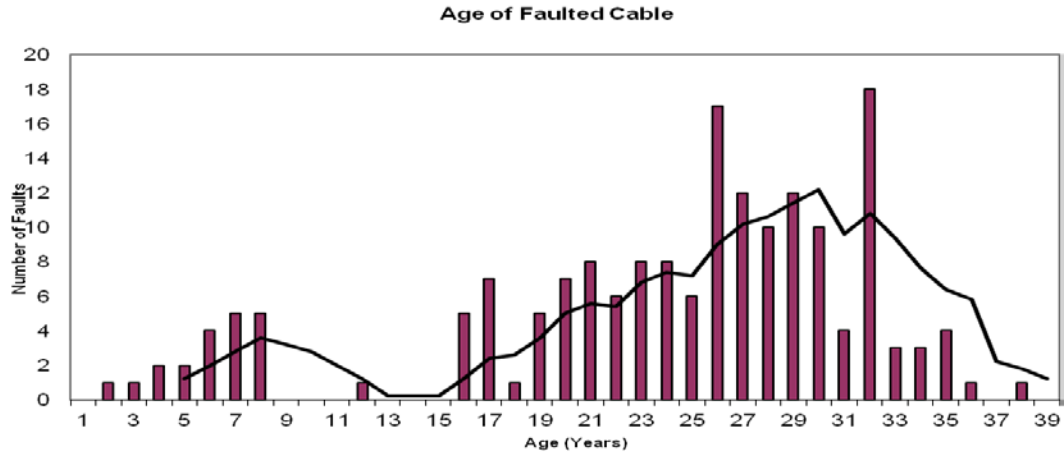
**Figure 9** XLPE Faults by Cable Age

Figure 9 demonstrates a substantial rise in XLPE failures occur once the cable age exceeds 25 years. The sharp drop in cable failures greater than 32 years was associated with the limited quantities of cable assets installed at the system in the early 1970's. The report also noted a small initial bump of cable failures between 7 and 10 years of age. These failures were associated with a localized region of defective cable installed on Springfield Feeder SD776 along Tu-Pelo Ave, in Winnipeg. These failures were most likely associated with manufacturing cable defects.

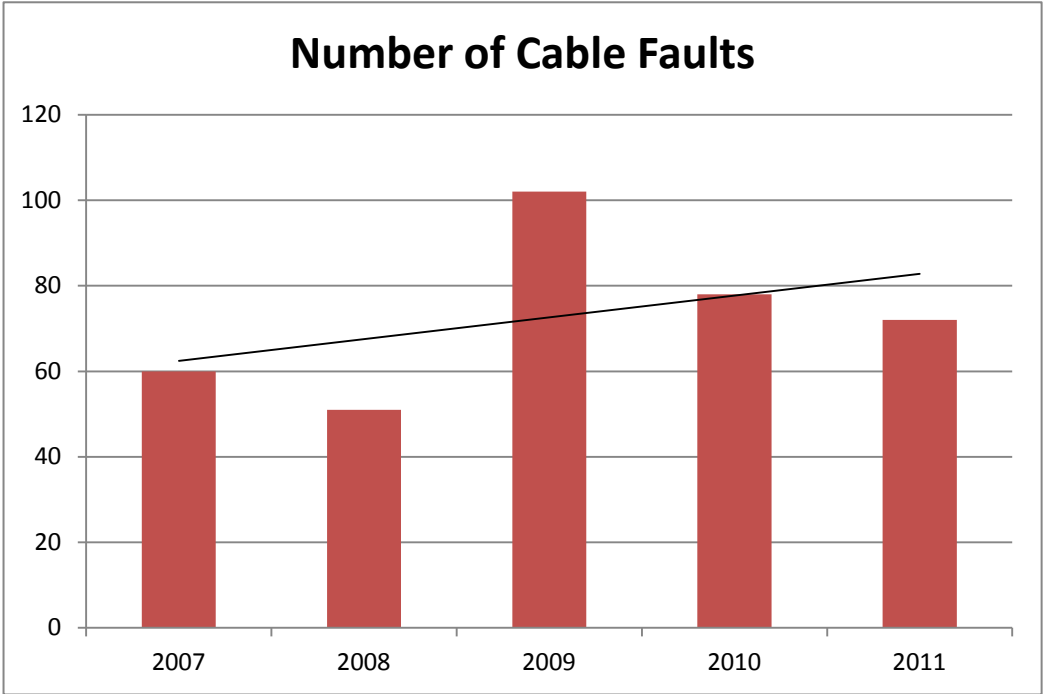
**Figure 10** Distribution Cable Annual Failure Rates

Currently, Manitoba Hydro does not have an established health condition rating system in place for underground distribution cables. Figure 10 provides an overview of all underground cable failures on Manitoba Hydro’s distribution system (4 – 25 kV) not associated with external factors such as dig-ins. Over the past five years, the number of underground cable faults has increased from 60 per year in 2007 to 72 in 2011 and averaged 72 faults per year over the analysis window. The number of cable failures increased by 12 per year, which translates into a 20% failure rate increase over the same five year timeframe.

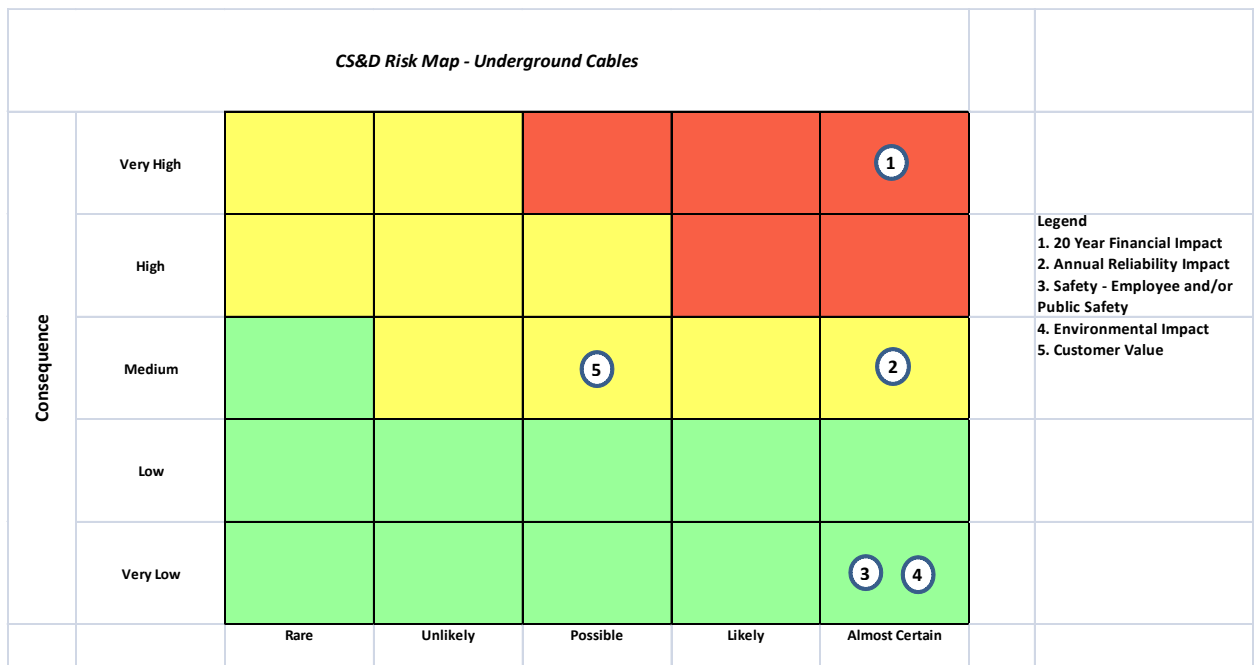
**Figure 12** Underground Cable Risk Map

Figure 12 indicates the several of the risks associated with underground cable failures are high. In the worst case scenario an underground cable failures will increase substantially and require extensive rehabilitation or replacement, particularly with the XLPE cable population.

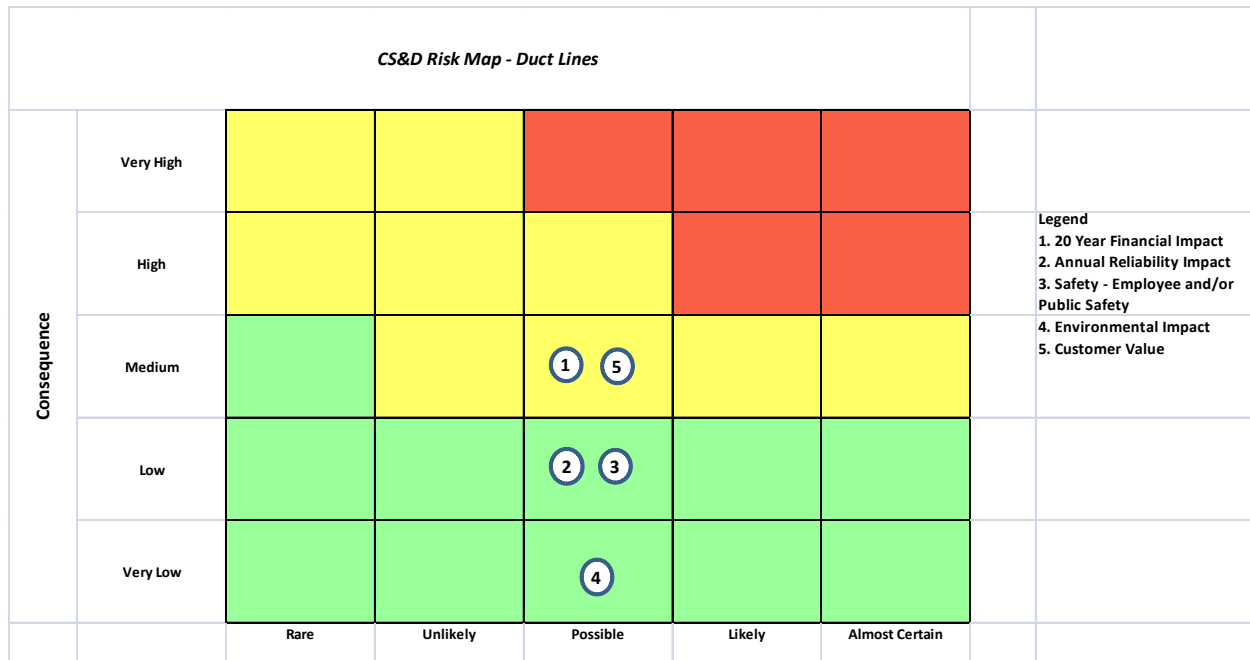
**Figure 22** Duct Line Risk Map

Figure 22 indicates that the risks associated with duct line failures range from low (environmental) to moderate financial & customer impact. In the worst case scenario a duct line

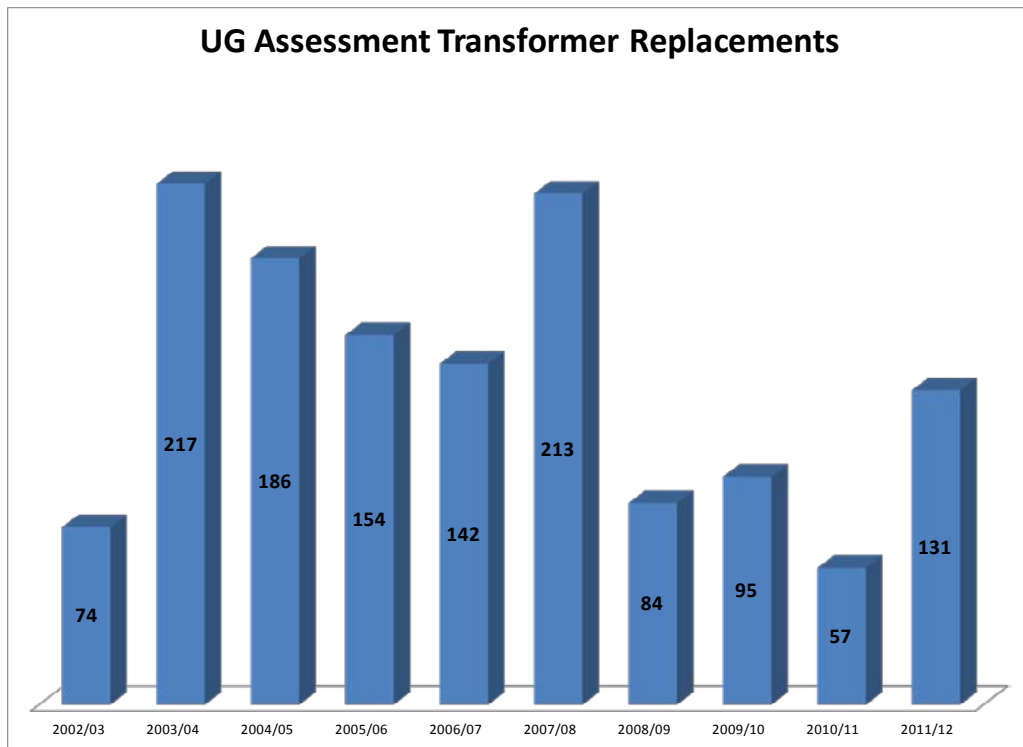
**Figure 27** Underground Assessment Crew Padmount Transformer Replacements

Historically, the Underground Assessment crew replaces between 50 and 220 padmount transformers on the distribution system annually. The majority of the units replaced (80%) are single-phase 50 kVA units with the remaining units a mixture of larger single-phase and three-phase padmount transformers. Details of the number of transformers replaced between 2002 and 2012 are provided in Figure 27.

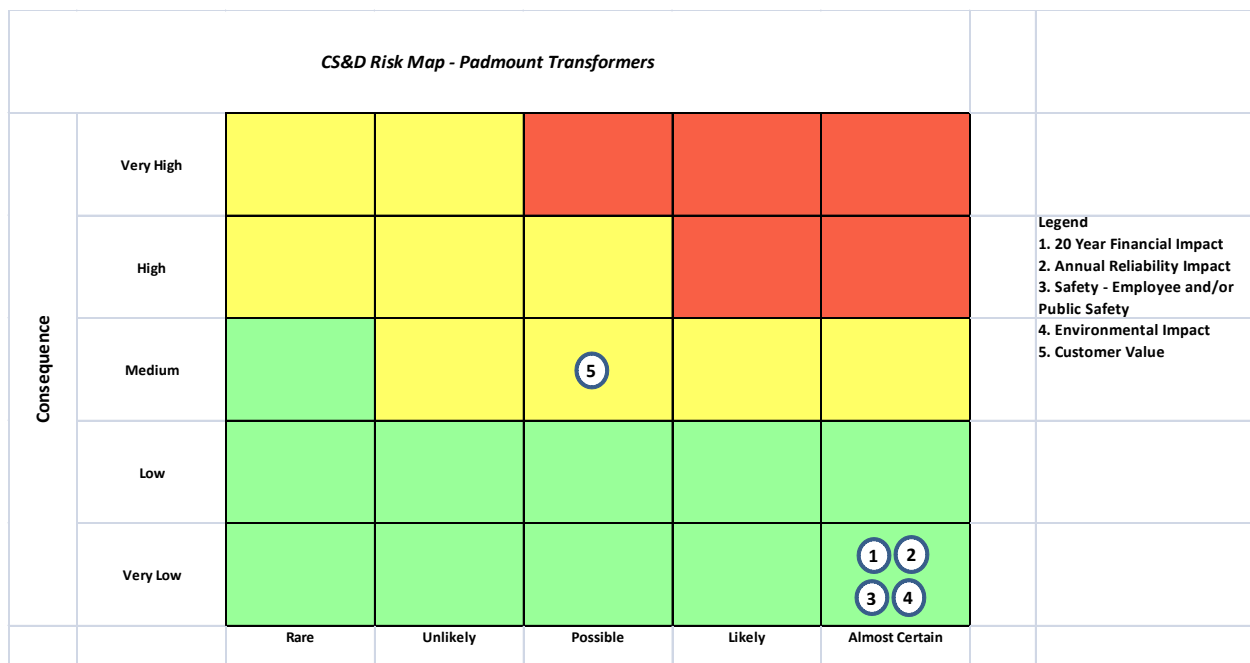
**Figure 29** Padmount Transformer Risk Map

Figure 29 indicates that the risks associated with padmount transformer failures are moderate. In the worst case scenario a padmount transformer failure could result in a lengthy outage to a high

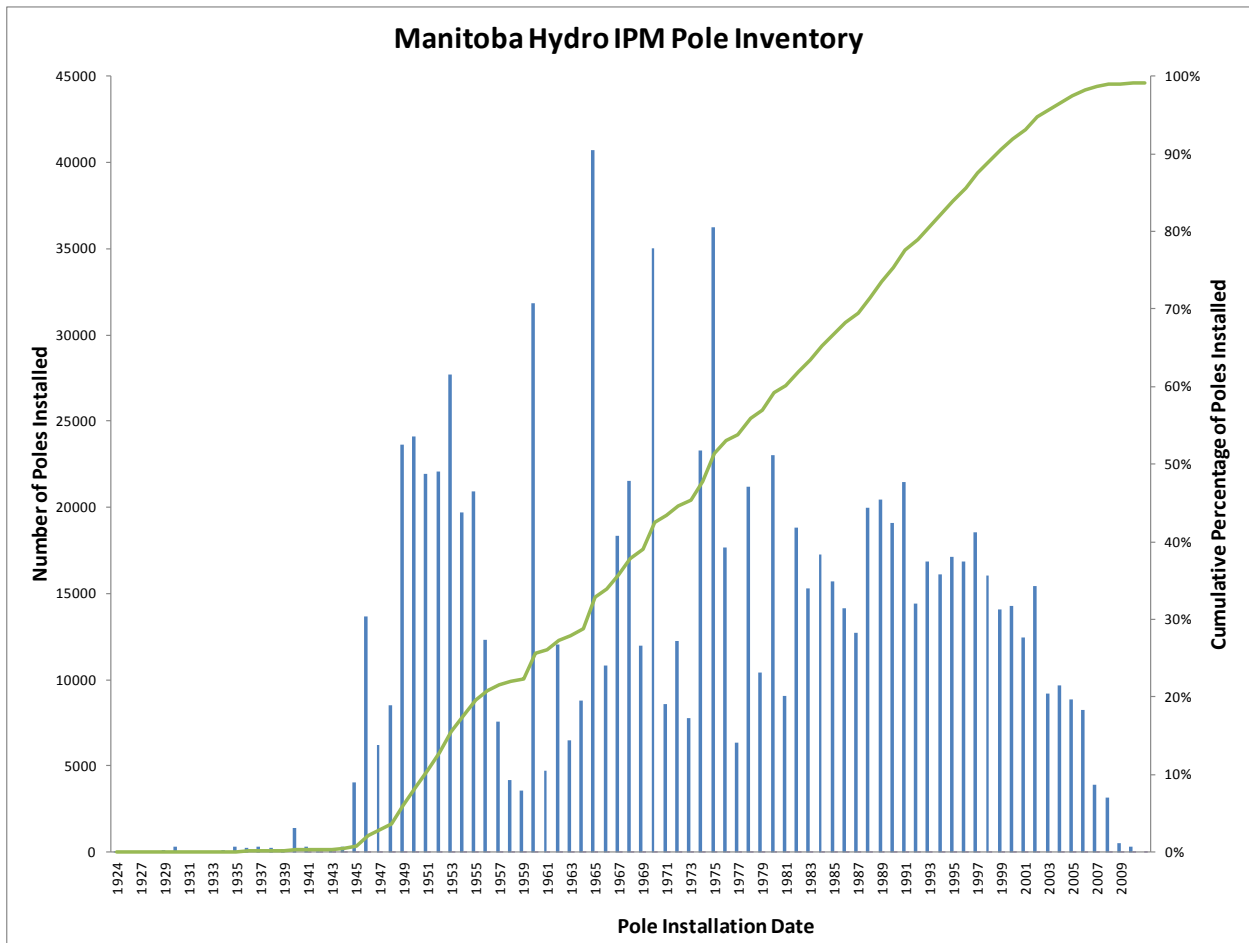
**Figure 32** Manitoba Hydro Projected Pole Inventory

In Figure 32, it is notable that Manitoba Hydro’s pole assets underwent a major expansion between 1945 and 1960. During that time approximately 250,000 poles were added to the distribution system. These poles are currently between 52 and 67 years of age and represent approximately 25% of the total pole population on the distribution system. Between 2020 and 2035, these poles will reach their anticipated lifespan of 75 years. Manitoba Hydro’s current pole replacement rate of approximately 5,000 poles per year is not sufficient to replace this first “hump” of poles when they reach their anticipated lifespan.

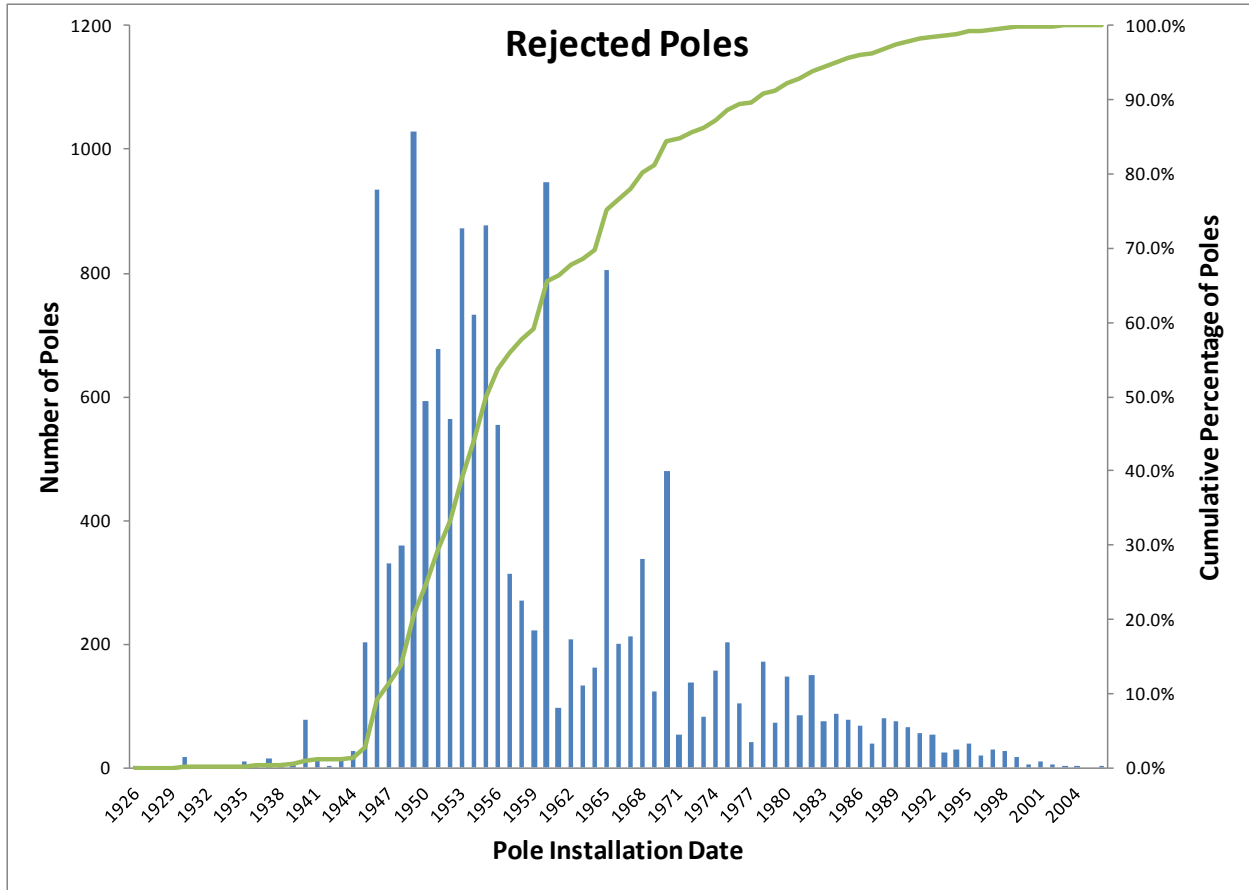
**Figure 35 Rejected Pole Age Profile**

The preceding chart indicates the majority of poles requiring replacement were installed between 1945 and 1960. Poles installed prior to 1960 account for 66% of rejected pole population. A graph of the rejected pole population as a percentage of total installed assets is provided in Figure 36.

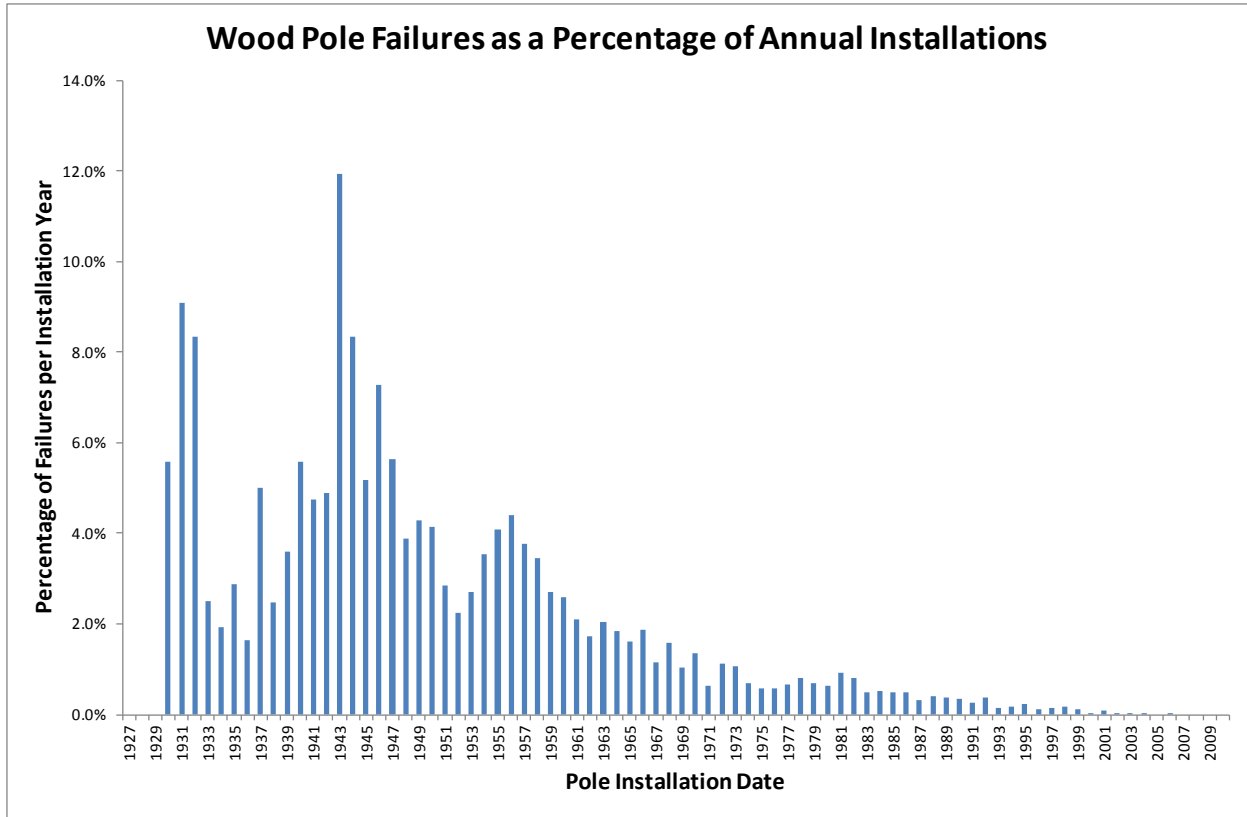
**Figure 36** Percent of Poles Requiring Replacement

Figure 36 details the percentage of service pole inspection failures by installation date. Failures range from less than 1% for pole installations since 1971 to 12% for poles installed in 1943. The typical upper range of pole failures ranges from 5% to 12% for poles installed prior to 1960. This data supports the conservative assumption that a 75 year lifespan for a pole is reasonable with typically less than 12% of assets that age failing in service. While relatively little data is available for poles older than 75 years, it is notable that the IPM data for the three 85 year old poles indicated a 66% failure rate. While only three poles that age were available for those data points, it is reasonable to assume in service failures would be more likely to occur with increasing pole age.

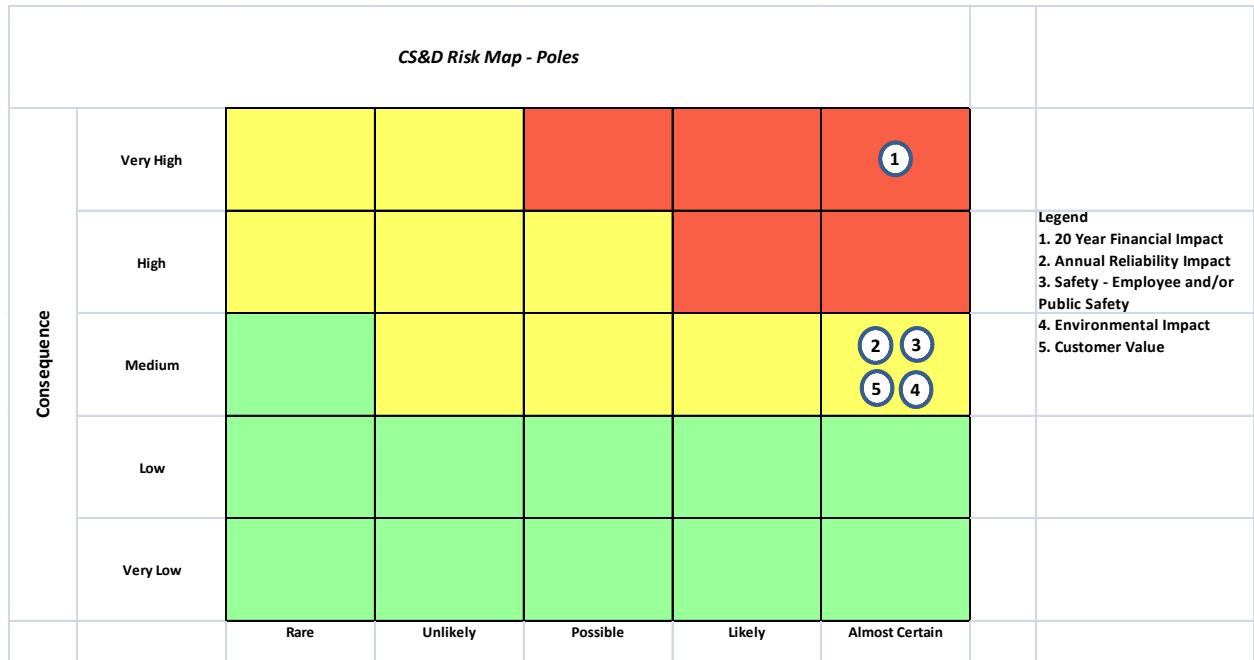
**Figure 38** Wood Pole Risk Map

Figure 38 indicates that the largest risk associated with wood poles is financial. With current replacement rates it is anticipated 12% of the wood pole population will be in critical condition within 20 years. At that time, the investment deficit will be approximately \$350 million. The remaining risks associated with wood failures are moderate and do not typically result in significant reliability, safety, environmental or customer value concerns.

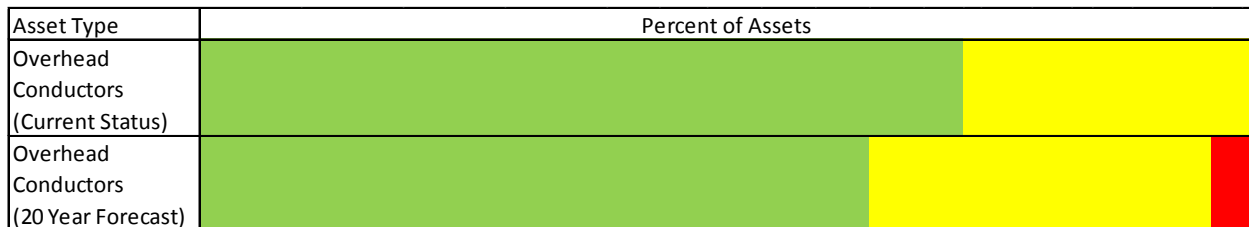
**Figure 42** Overhead Conductor “Soccer Field”

Figure 42 indicates approximately 28% of the overhead conductors installed on Manitoba Hydro's distribution system are in fair/poor condition. This number is anticipated to degrade slightly to 31%, assuming the current annual salvage rate of 50 km for 3/13" steel is maintained. Generally speaking, conductors are assumed to outlast the wood poles supporting them, however approximately 3% of conductors are anticipated to transition to critical condition over the next 20 years. If that scenario holds, the replacement of the conductor would cost \$63 million.

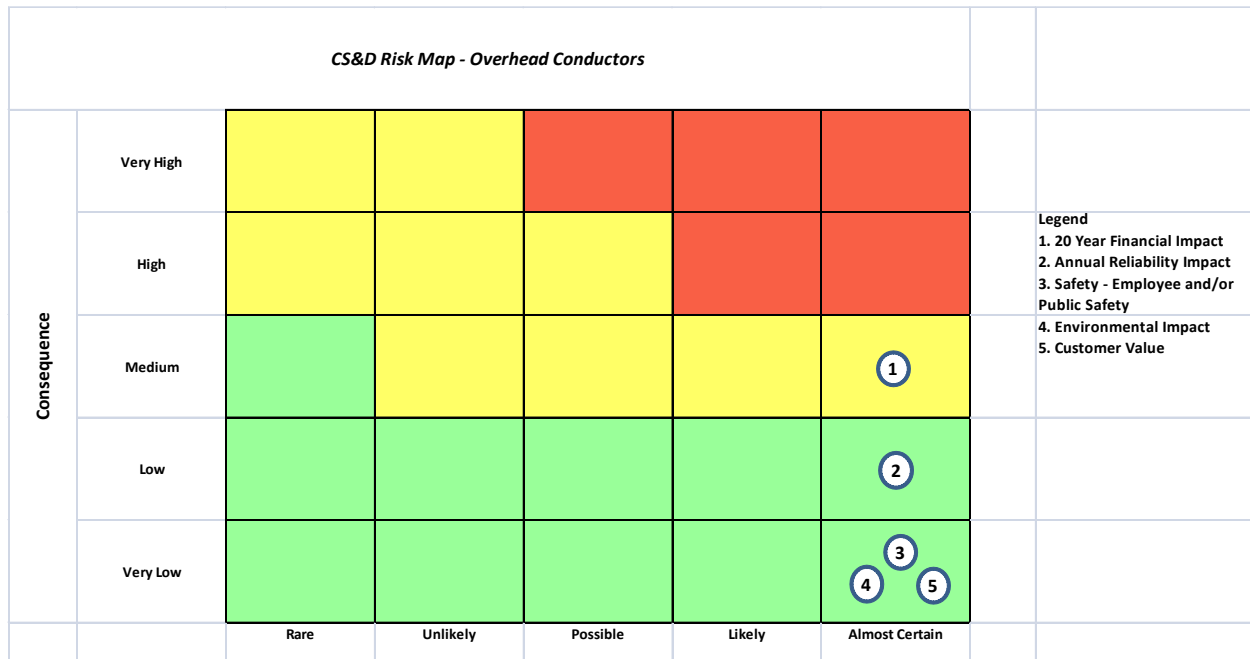
**Figure 43** Overhead Conductor Risk Map

Figure 43 indicates that the risks associated with overhead conductor failures are moderate. In the worst case scenario a conductor failure would impact a major 66 kV or 24 kV circuit and result in an outage impacting several thousand customers for several hours. These types of failures are readily repairable by operational staff.

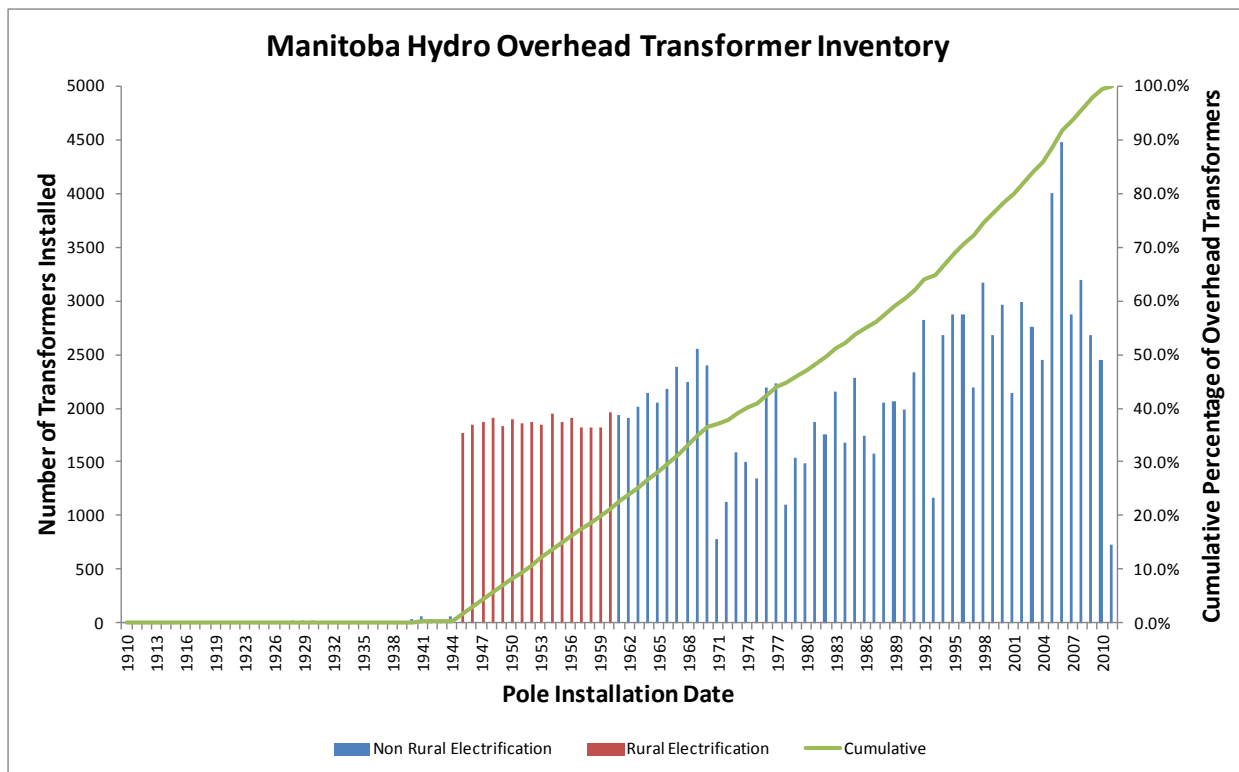
**Figure 46** Manitoba Hydro Overhead Transformer Inventory

Figure 46 indicates that Manitoba Hydro’s overhead transformer assets have ranged between 1000 and 4500 installations per year. Of these assets 21% or 30,000 units were installed prior to 1960 and will be approaching the end of their serviceable life within the next several years. Although there is uncertainty in the installation dates for transformer installations prior to 1970, Manitoba Hydro’s current transformer replacement rate is anticipated to be adequate for the first “hump” of assets when they reach their anticipated lifespan.

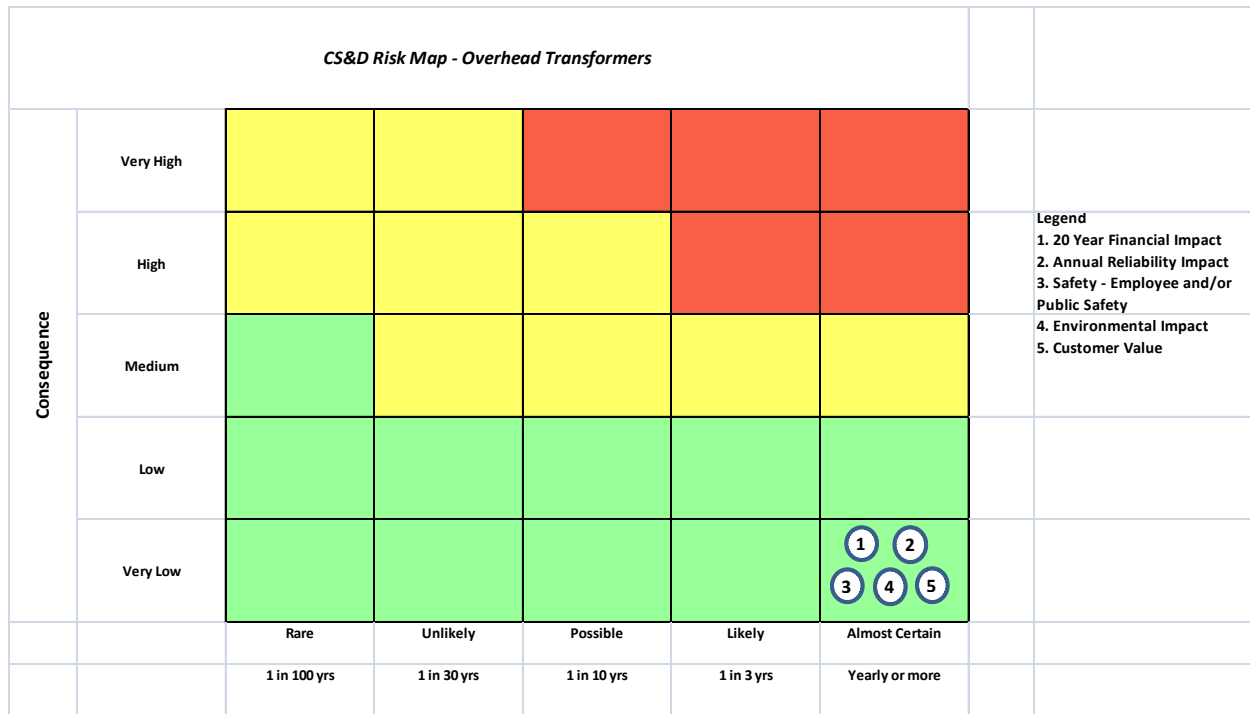
**Figure 49** Overhead Transformer Risk Map

Figure 49 indicates that the risks associated with overhead transformer failures are low. In the worst case scenario an overhead transformer failure could result in a lengthy outage to a high profile customer which could receive result in high profile local media attention.

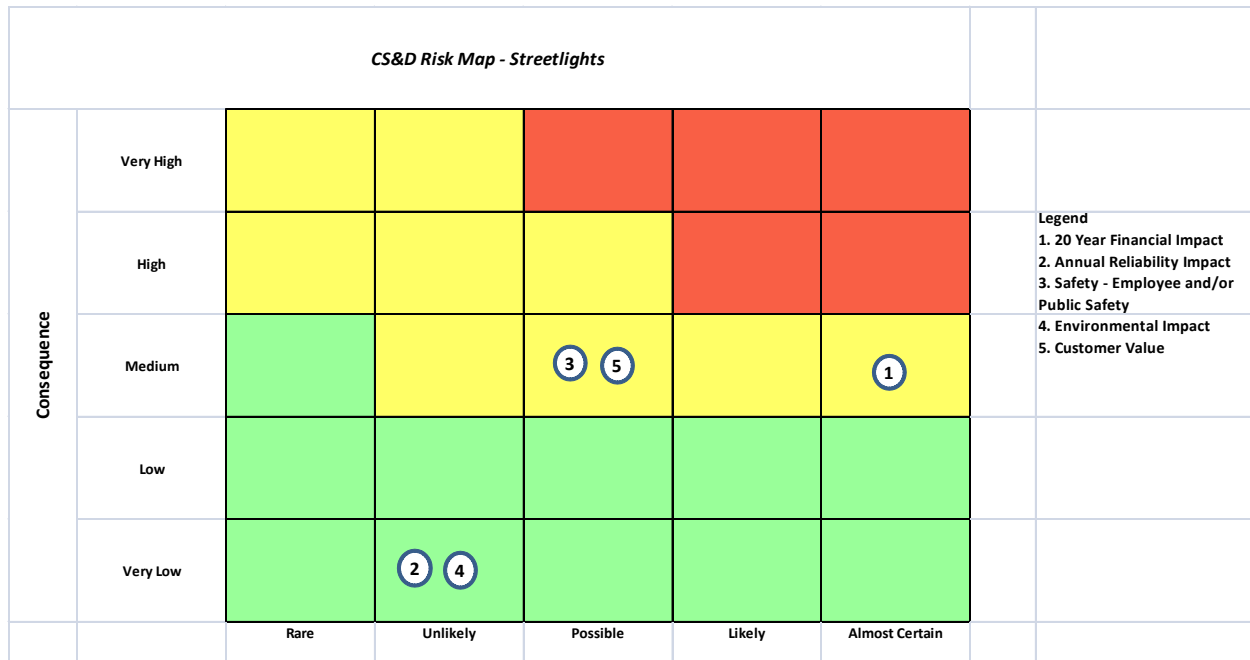
**Figure 55** Streetlight Risk Map

Figure 55 indicates that the risks associated with streetlight standard failures are moderate. The existing replacement rates appear to be adequate if diagnostic tools can be utilized to identify below grade corrosion issues on direct buried and power screw anchored standards prior to failure and if 50% of existing installations of these types degrade to unacceptable levels over the next 20 years. The worst case scenario of a streetlight blow down coming into contact with the public is a concern. In addition to the risk of property damage or public injury there is also a potential for highly visible local media coverage.
