MANITOBA HYDRO

2012/13 & 2013/14 ELECTRIC GENERAL RATE APPLICATION

PUBLIC UTILITIES BOARD (“PUB”) PRE-ASK QUESTIONS OF MANITOBA HYDRO

**Pointe du Bois Spillway Replacement
Incremental Consequence Classification and
Selection of Inflow Design Flood
Deliverable No: P-1.3.2.2.0440.1 Rev 0
Manitoba Hydro File 00102-11340-0011_02**

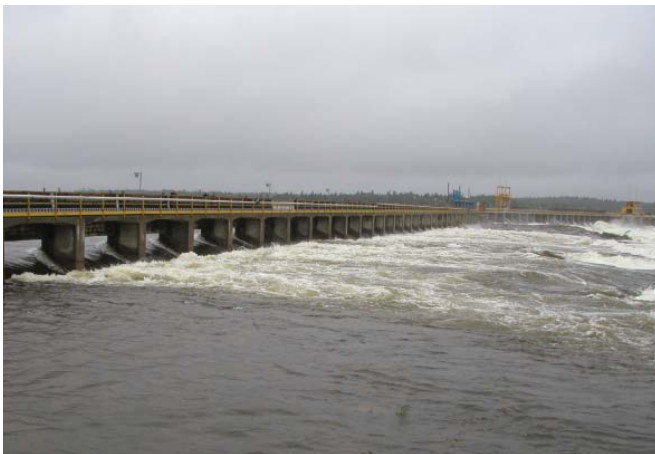
Photo 1: General downstream view of spillways and sluiceways.

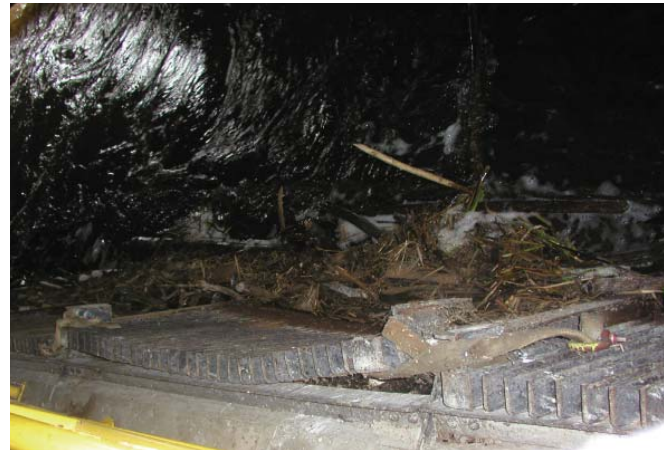
(a) powerhouse intake					
- accumulation or obstruction by debris or ice	✓	✓			Slight debris upstream at units 2, 3, 5-10. Considerable debris upstream at units 1 and 12-16. Damaged trashracks at units 6 and 9 (Photo 2).

Photo 2: Damaged trashrack and debris upstream of unit 6.

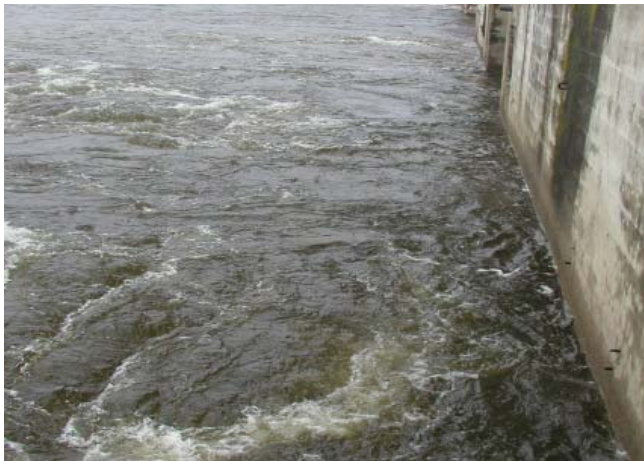
Photo 3: Turbulence at powerhouse tailrace

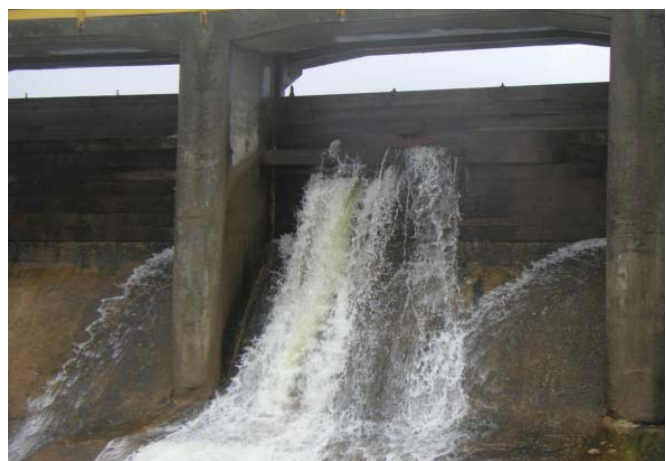
- obstruction by debris or ice or vegetation	✓				
- eddies, vortices, cross waves, erosion-deposition & tailwater submergence effects	✓				
(d) curved spillway (bays 101 to 114)					Severe leakage in bay 112, due to damaged stoplogs (Photo 4).

Photo 4: Stoplogs are damaged in the curved spillway bay 112.

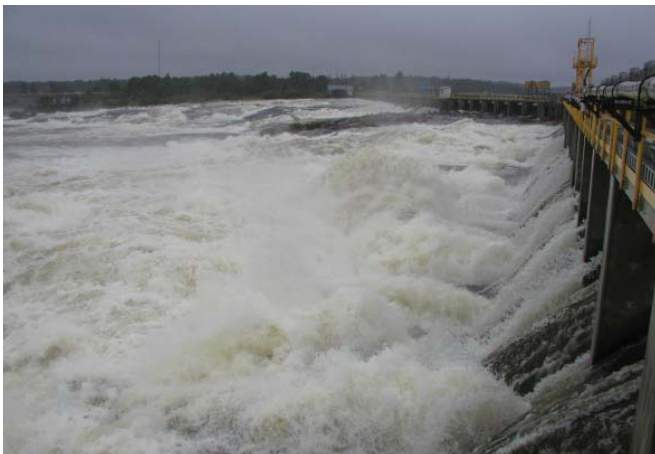
- obstruction by debris or ice or vegetation	✓				
- eddies, vortices, cross waves, erosion-deposition & tailwater submergence effects	✓				
(g) spillway (bays 45 to 65)					Spilling in bays 47, 49-52 and 56-65 (Photo 5).

Photo 5: Turbulence downstream of spillway bays 45 - 65; spilling through bays 47, 49-52 and 56-65.

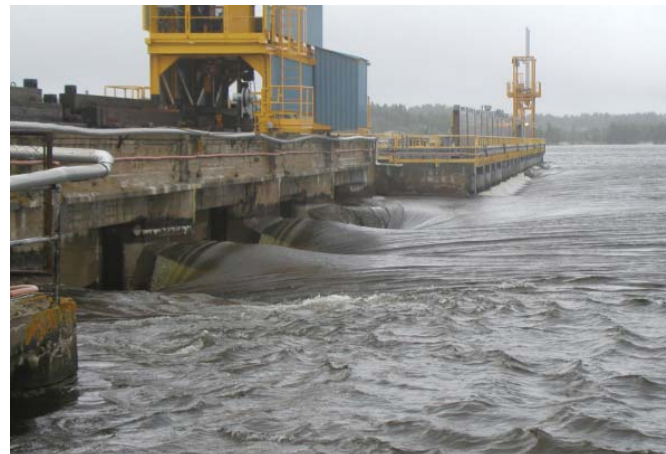
- obstruction by debris or ice or vegetation	✓				
- eddies, vortices, cross waves, erosion-deposition & tailwater submergence effects	✓				
(h) sluiceway (bays 1 to 5)					Spilling in bays 2, 3, and 4 (Photo 6). Excessive leakage through logs in bays 1 and 5. Backflow into bay 1.

Photo 6: Upstream sluiceway, spilling through openings 2, 3 and 4.
