# Manitoba Hydro 2012/13 & 2013/14 General Rate Application

**REPORT ON**

**Distribution Asset Condition**

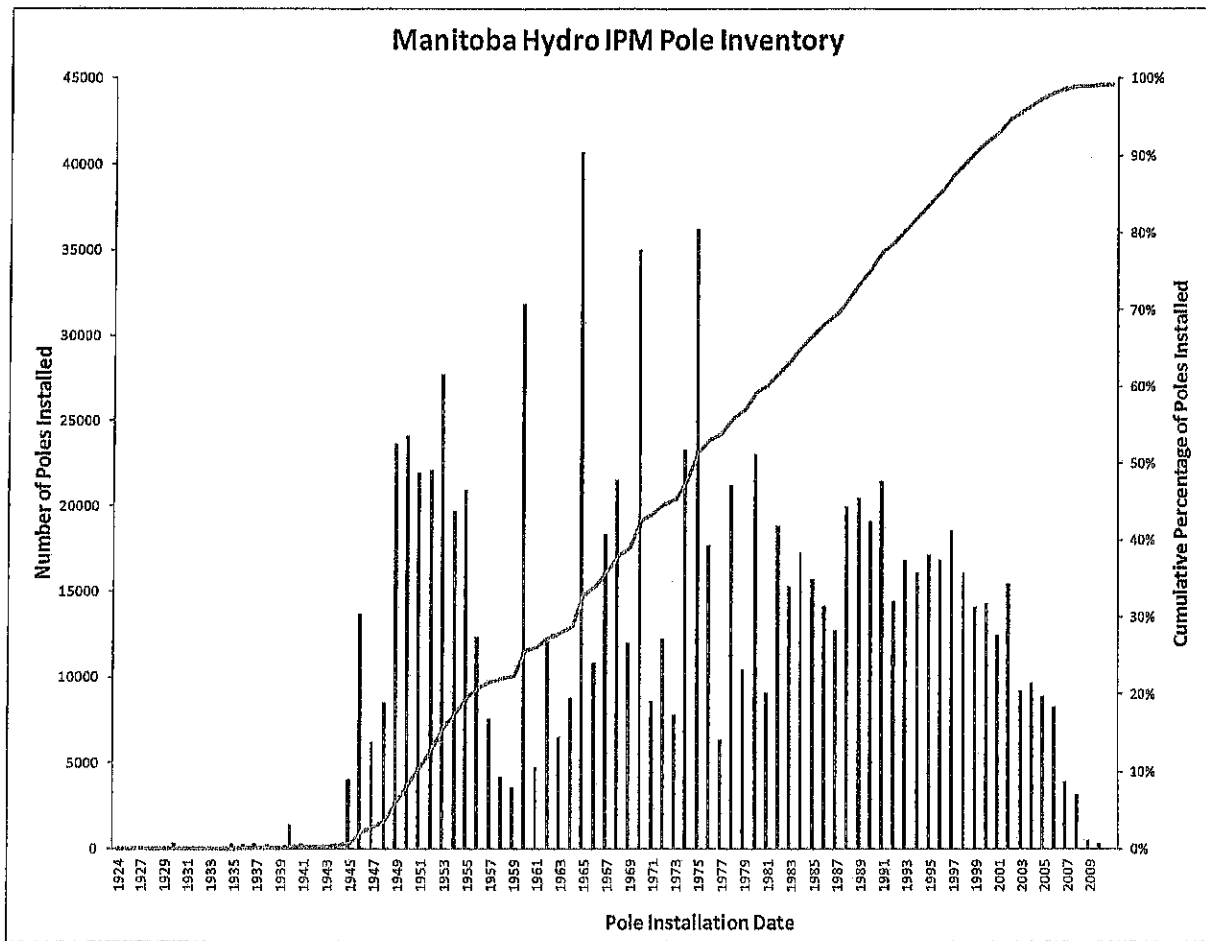
**Figure 32** Manitoba Hydro Projected Pole Inventory

The Integrated Pole Maintenance Program (IPM) database which contains records of wood pole age, species, class, and pole treatment history, currently contains 525,465 pole records from 2003 to 2010 and is estimated to comprise 53% of the total 1,000,000 pole inventory. Using this data a projection of the anticipated age of Manitoba Hydro's pole assets is shown in Figure 32. The individual blue bars correspond to the estimated number of poles installed each year. The green line corresponds to the total cumulative percent these poles represent for the total pole inventory.

In Figure 32, it is notable that Manitoba Hydro’s pole assets underwent a major expansion between 1945 and 1960. During that time approximately 250,000 poles were added to the distribution system. These poles are currently between 52 and 67 years of age and represent approximately 25% of the total pole population on the distribution system. Between 2020 and 2035, these poles will reach their anticipated lifespan of 75 years. Manitoba Hydro’s current pole replacement rate of approximately 5,000 poles per year is not sufficient to replace this first “hump” of poles when they reach their anticipated lifespan.

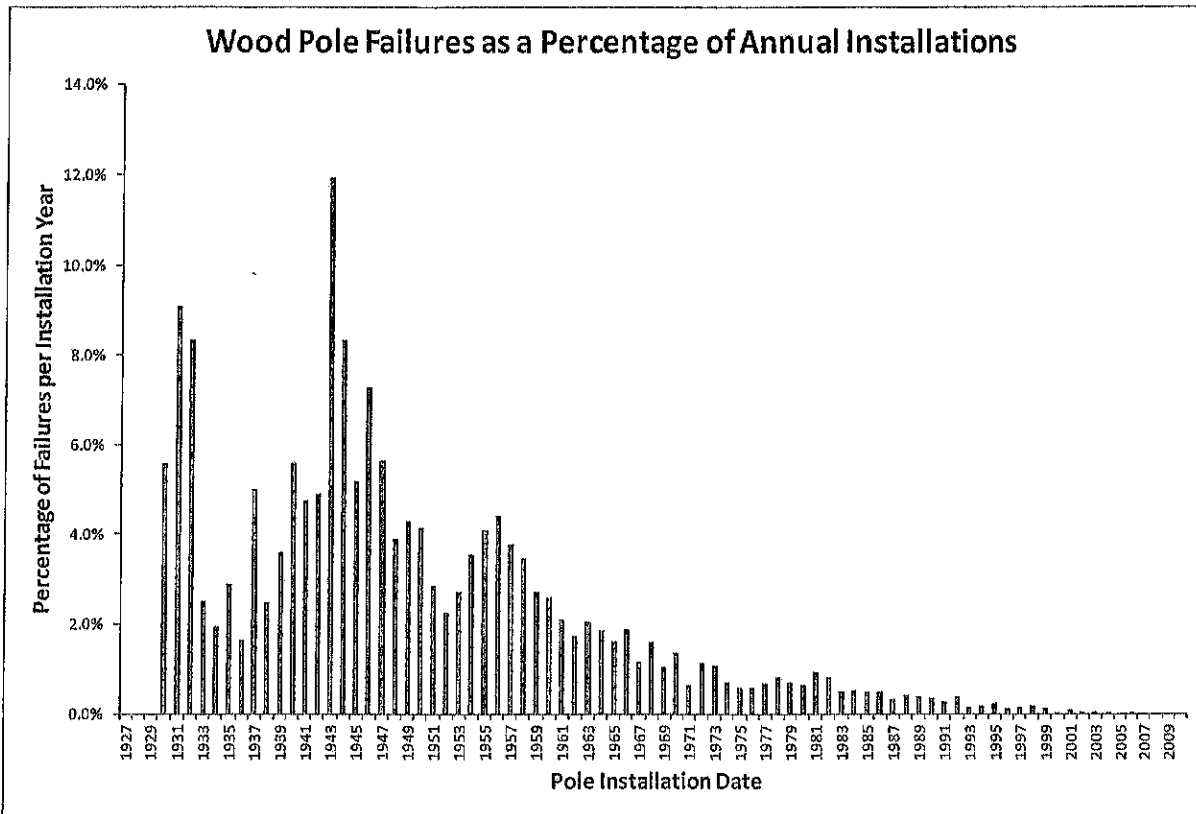
Figure 36 Percent of Poles Requiring Replacement

Figure 36 details the percentage of service pole inspection failures by installation date. Failures range from less than 1% for pole installations since 1971 to 12% for poles installed in 1943. The typical upper range of pole failures ranges from 5% to 12% for poles installed prior to 1960. This data supports the conservative assumption that a 75 year lifespan for a pole is reasonable with typically less than 12% of assets that age failing in service. While relatively little data is available for poles older than 75 years, it is notable that the IPM data for the three 85 year old poles indicated a 66% failure rate. While only three poles that age were available for those data points, it is reasonable to assume in service failures would be more likely to occur with increasing pole age.
